93021

1.8T 110-132 KW

ISSUE POSSIBLE OIL CARBONIZING AND FLOW RESTRICTIONS

OIL FEED LINE PLACED VERY CLOSE TO THE EXHAUST MANIFOLD

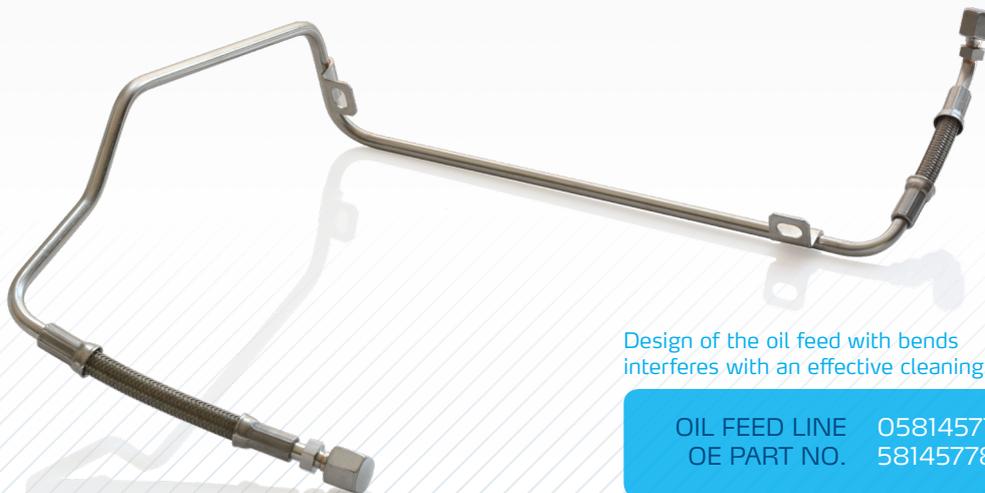
OIL FEED LINE 058145778C, 058145778
OE PART NO. 58145778

The turbo oil feed line in this particular engine model is placed very near the engine's exhaust manifold. The high temperatures generated by the exhaust gases flowing through the manifold exposes the oil stream inside the feed line to high thermal stress. This leads to the formation of solid particles inside the pipe due to oil coking and carbonizing.

Consequently, the feed oil flow gets restricted. An excessive formation of the particles will contaminate the lubricant. Particles, when loosened (e.g. by moving the pipe) can then get to the turbo bearing/shaft. All these instances are very harmful to the shaft operation. The shaft gets under-lubricated and will seize. Seizure can block the shaft completely and cause the compressor nut to unscrew, leading to further mechanical damages.

Design of the oil feed with bends interferes with an effective cleaning

- **Install new oil feed line** (Effective cleaning impossible due to design)

Once turbo is installed, remember to check the oil pressure on the oil feed line or check the oil flow when decoupling the oil return line from the installed turbo
